Hospital bathroom ergonomics: Safety, usability and accessibility issues

Edda Maria Capodaglio

Salvatore Maugeri Foundation, IRCCS, Scientific Institute of Pavia, via Severino Boezio, Pavia, Italy

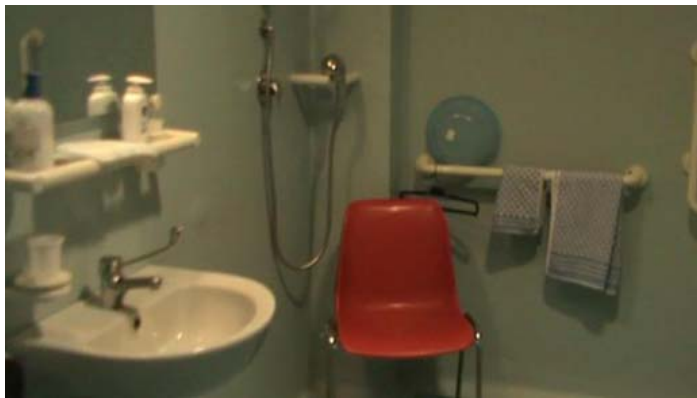
Figure. Inadequate adaptation of a shower seat

The shower seats were only partially provided and some of them were not firmly fixed to the wall, thereby increasing the risk of fall in case of overweight patients; in some cases they were fixed at an excessive height if compared to the standard wheelchair seat, requiring additional effort by the assisting nurse.
